## Microbiologically Influenced Corrosion Failure Analysis of 304L Stainless Steel

**Susan Borenstein**, Aptech Engineering Services  
Houston, Texas

An AISI Type 304L stainless steel piping system failed due to microbiologically influenced corrosion (MIC) after being in contact with stagnant, low chloride potable water for nine months. This report discusses this failure and uses it to illustrate common problems associated with MIC in piping systems and other equipment.

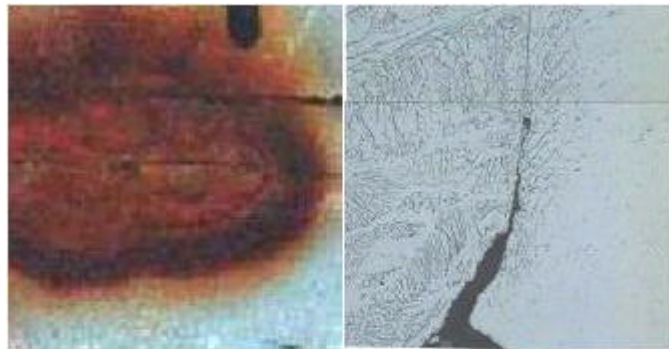
Several areas were selected for metallurgical examination. Figures 1-3 show the results of this examination. The morphology of the pits found in the stainless steel were jagged, a characteristic of MIC but not of more conventional crevice corrosion in stainless steel.

Figure 1—Overview of pit on corroded 304L stainless steel weld

Figure 2—Closeup showing deep crevice adjacent to weld bead/base metal interface

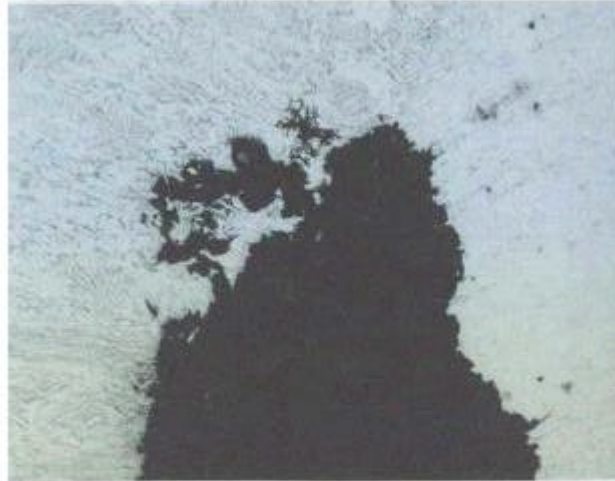
Figure 3—MIC-induced pitting in the weld region of a 304L stainless steel piping system.
