## Copper in Architecture

### Finishes - Natural Weathering

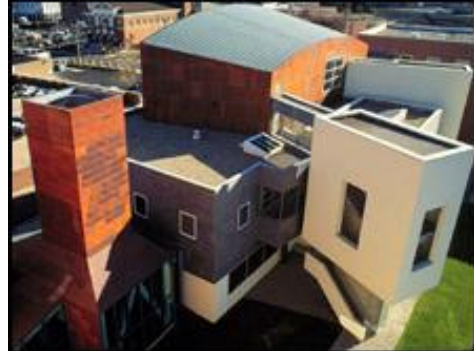
As natural weathering proceeds, the metal exposed to the atmosphere changes in hue from the natural salmon pink colour through a series of russet brown shades to light and dark chocolate browns and finally to the ultimate blue-green or gray-green patina.

During the initial weeks of exposure, particularly in a humid atmosphere or in areas of frequent rainfall, radical colour changes often take place with iridescent pinks, oranges and reds interspersed with brassy yellows, blues, greens and purples. During continued exposure, these interference colours fade and are replaced by relatively uniform russet brown shades, referred to as statuary or oxidized finishes.

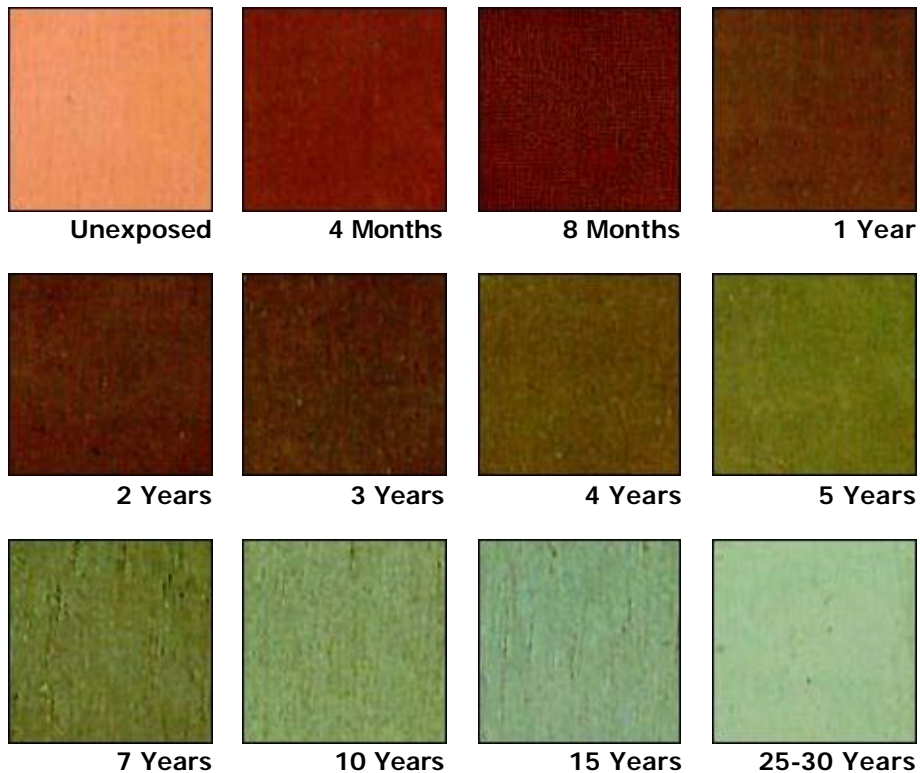
## Copper Weathering Chart

The progressive oxide, sulphide and sulphate films which develop on copper exposed to the atmosphere are quite thin – 0.05 to 0.08 millimetres - and highly adherent, but with relatively low abrasion resistance. Neither the oxide nor sulphide films are particularly corrosion resistant. The sulphate patina, on the other hand, is highly resistant to all forms of atmospheric corrosion, once it has formed completely. It thus significantly increases the durability and, hence the service life of copper roofing and flashing. The natural weathering cycle of copper is illustrated by the 12 sequential colour plates in the Weathering Chart on the next page.

Although the plates represent a typical sequence, the weathering of any installation will depend on local environmental factors, orientation and amount of residual lubricants.

The weathering of copper will reach a final equilibrium with its local environment. This state of equilibrium is very stable and no further weathering will occur after this state is reached. However, the final equilibrium colour will vary depending on orientation, slope, and local weather conditions.
